MISCELLANEOUS PAPER NO. 4-829

FIELD TESTS OF AM3 LANDING MAT

**U. S. Army Engineer Waterways Experiment Station
CORPS OF ENGINEERS**

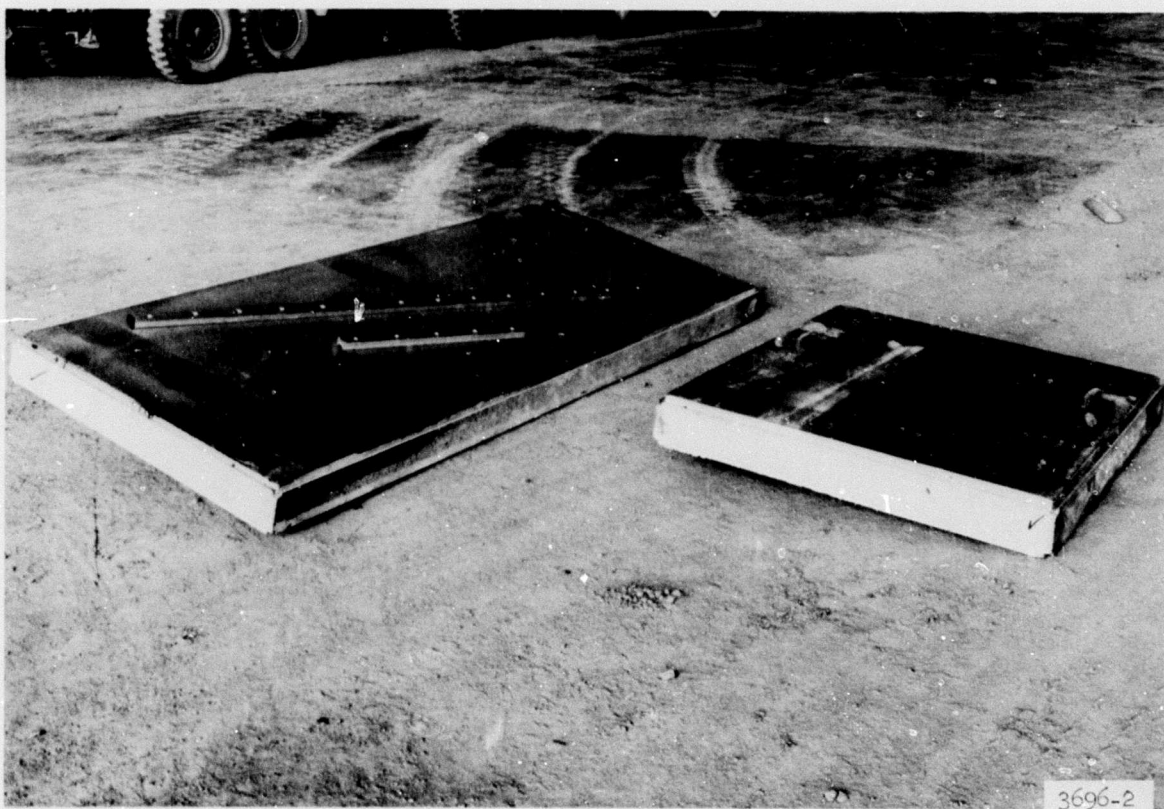
Photograph 2. Whole and half panel of AM3 mat

5. Photograph 2 shows a whole and a half panel of AM3 mat. For this investigation, 237 whole panels and 21 half panels of AM3 mat were furnished. The AM3 mat was made by the Aluminum Corporation of America (ALCOA), New Kensington, Pa., under contract with the Department of the Navy. Overall dimensions of the panels were: length, 97-5/16 in.; width, 39-3/16 in.; and thickness, 5.520 in. The width of the top side of the panels averaged 0.09 in. more than the width of the bottom side. This caused a crown to develop in the pad during the pond tests, as described subsequently in paragraph 10. The average weight of one panel was 183.14 lb without connectors, and 212.64 lb with connectors. The weight of the panel with connectors per square foot of placing area was 7.87 lb. The placing area of one panel with connectors was 27.02 sq ft.

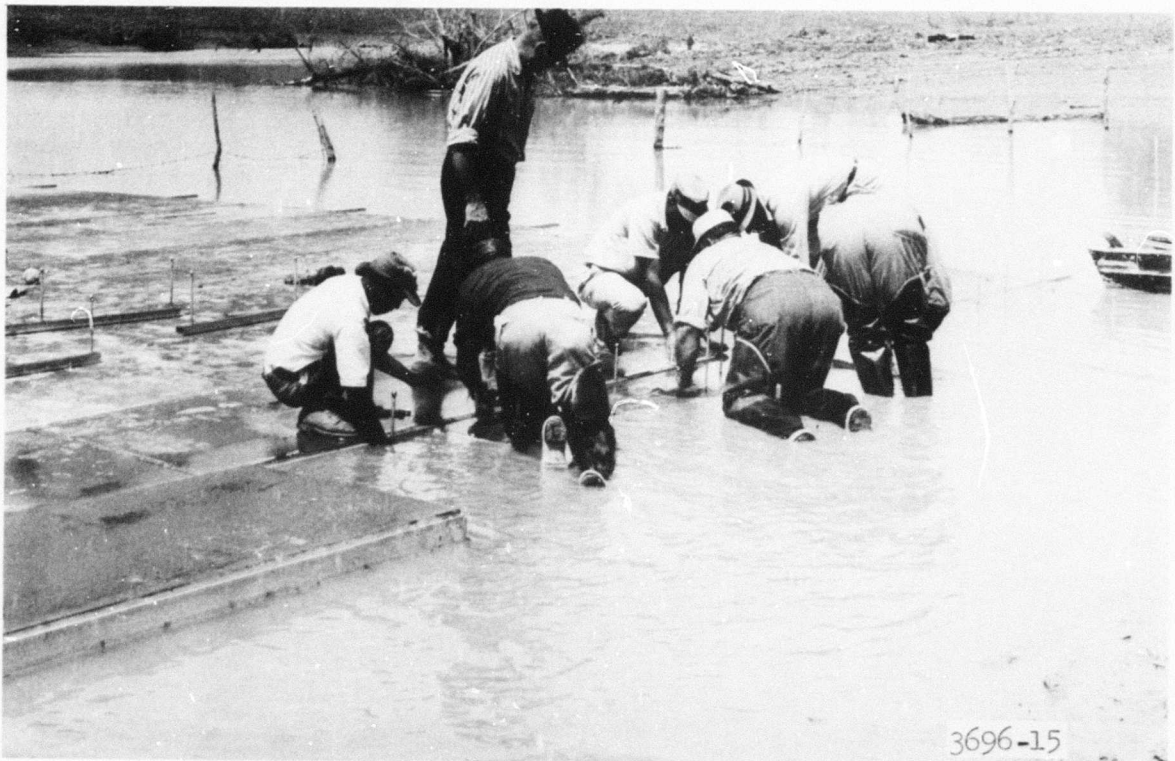
Photograph 9. New panel being forced underwater in order to connect it to pad

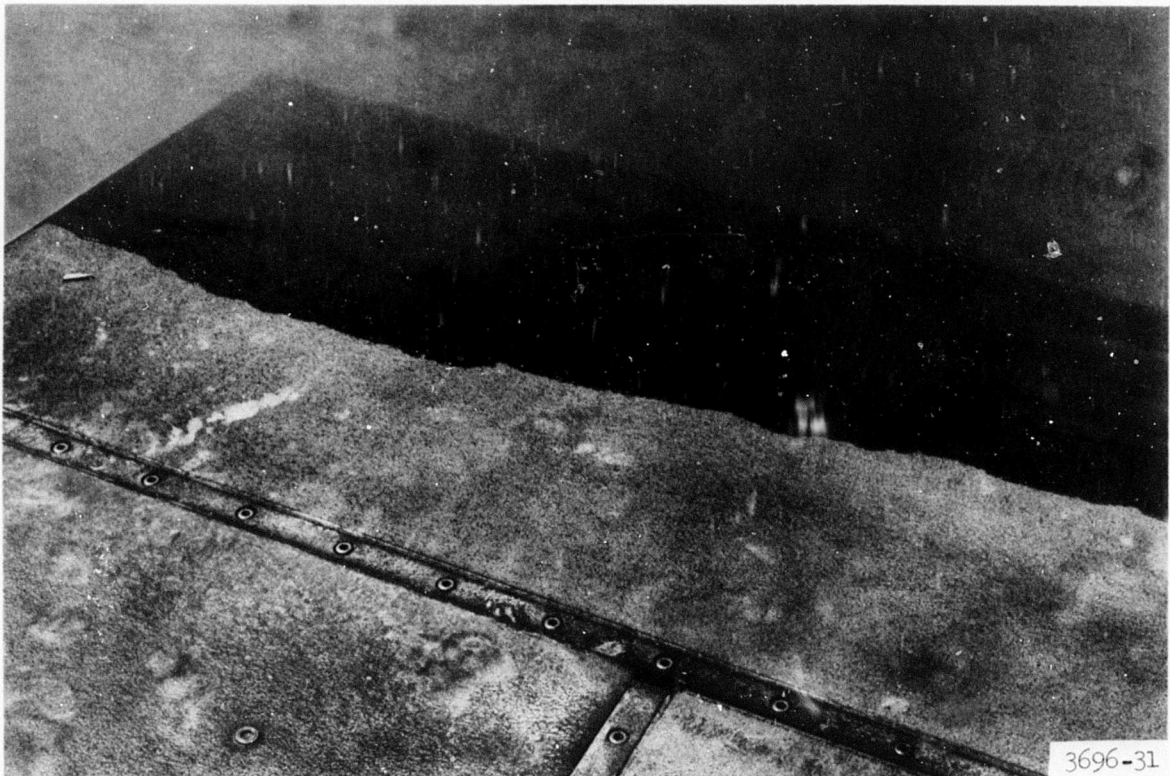
Photograph 12. Closeup of corner of run 1 with edge underwater

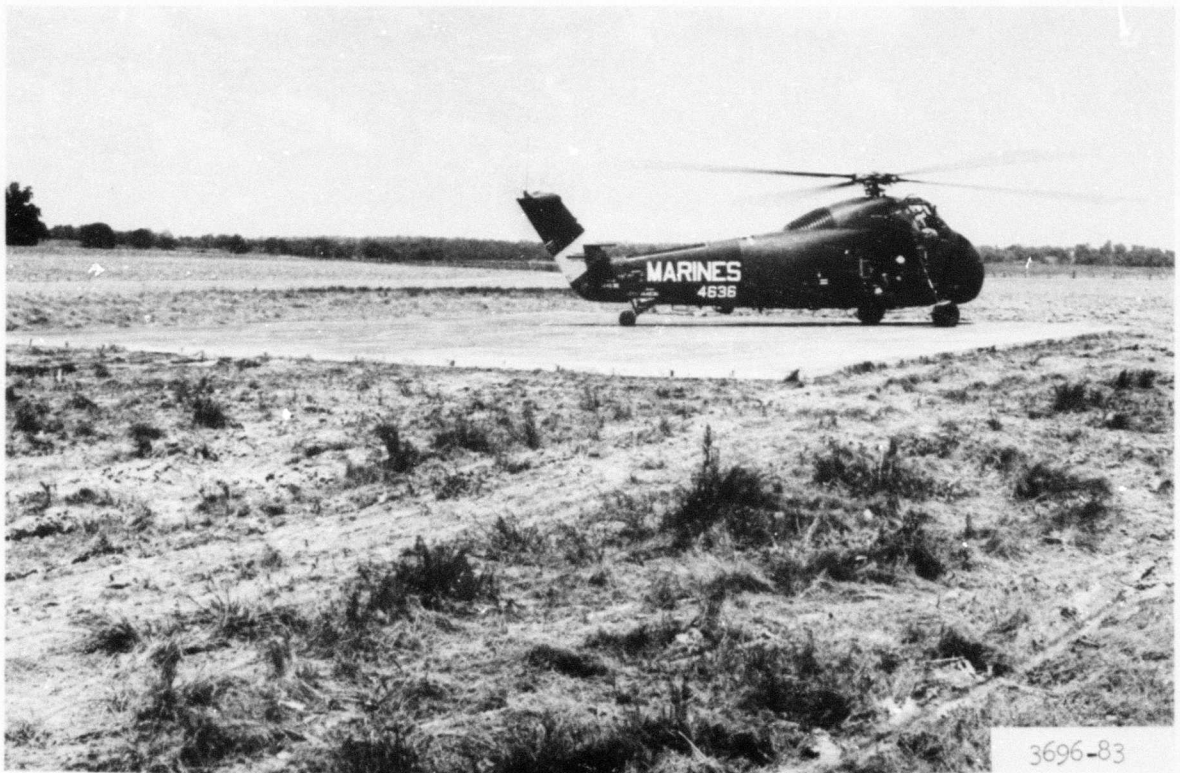
Photograph 25. Helicopter on edge of pad after making a rolling landing across pad; gross aircraft weight, 12,000 lb

these tests with the 12,000-lb load. The helicopter touched down on one corner, taxied to the opposite corner, and halted abruptly at the pad's edge (photograph 25). This simulated a normal landing for a helicopter operating with a maximum cargo load. The craft again taxied over the entire pad, with the main gear wheels coming within inches of the edge (photograph 26). The helicopter also taxied along and across the depressed joint between runs 14 and 15 (paragraph 19). The depressed area was trafficked with the tail wheel (photograph 27) and main gear wheels (photograph 28) with no adverse effects being noted. The only visible damage to the pad was flaked-off antiskid compound. This was particularly evident when one tire was braked and 360-deg turns were made. Loose antiskid compound was observed on 20 panels during and after the tests. It is believed that exposure to water during the pond tests weakened the bond between the antiskid compound and the panels. The CBR was determined at each corner of the pad and also near the center of the pad after one panel was removed. The average CBR in the top 12 in. was 0.26 percent.

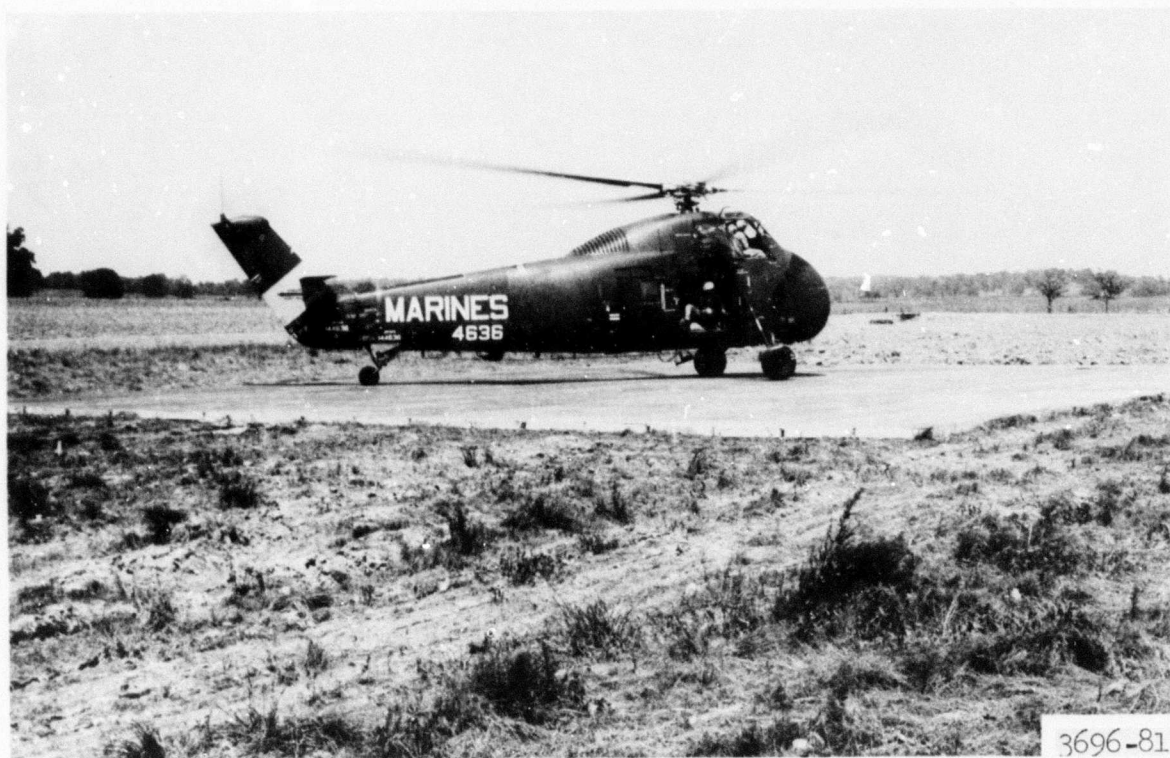
Photograph 28. Main wheel trafficking depressed area shown in photograph 21
